**Flood Control Project Maintenance
Levee Inspections**
LMA District Cover Sheet
Spring 2016 Levee Inspection Results

Reclamation District No. 1601 Twitchell

Levee Inspection Report By Mile - Spring 2016

Waterway	Bank	Unit Miles	Inspection Start/End	Inspector
Unit No. 01 Threemile Slough	Left	2.43	03/29/2016 03/29/2016	Richard Willoughby

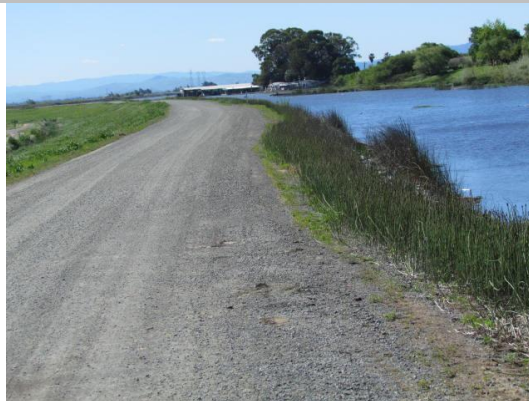
Photo 1 of 1 : SP_2016_RD1601_237_15_20160330_00019.jpg

LM Start	0.00	Rating **	M	Issue No.	15
LM End	2.43	Issue Type +	Ma	Location *	WS
Category	Earthen Levee			GPS Latitude/Longitude	
				Start	End
Item	Vegetation			38.122250 °	38.087655 °
				-121.682517 °	-121.683761 °
DWR ID	DWR_RD1601_01_s _ 2016_15				
Comment Code					
V1 : Control annual grass and weeds on the levee slopes and easements.					
Inspector Comment

Looking west at typical view of waterward slope.

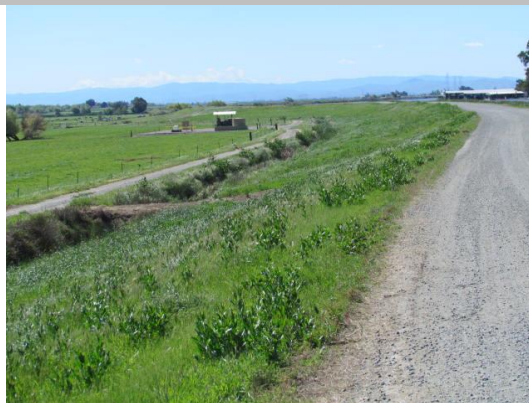
Photo 1 of 1 : SP_2016_RD1601_237_14_20160330_00020.jpg

LM Start	0.00	Rating **	M	Issue No.	14
LM End	2.43	Issue Type +	Ma	Location *	LS
Category	Earthen Levee			GPS Latitude/Longitude	
				Start	End
Item	Vegetation			38.122250 °	38.087655 °
				-121.682518 °	-121.683761 °
DWR ID	DWR_RD1601_01_s _ 2016_14				
Comment Code					
V1 : Control annual grass and weeds on the levee slopes and easements.					
Inspector Comment

Looking southwest at typical view of landward slope.

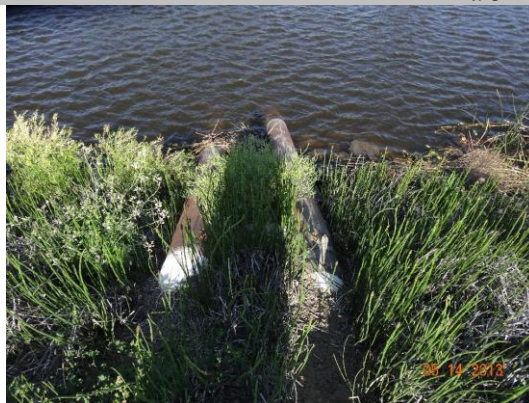
Photo 1 of 2 : UCIP_SP_2016_22043_37621.jpg

Comment Code					
Inspector Comment					
FS_ID:22043 DS_ID:20950 EP_NO: 11227 Repair Type: Non-Urgent Crossing Status: Found UCIP Comments: Appears this crossing might be been recently modified--exposed section of pipe is protected with white paint. Need to contact owner to obtain records. Recommend clearing vegetation along the pipe alignment. FIELD_STRUCT_DESC: 14-inch pipe (not 12-inch pipe as original description noted) through the levee, 4.0 feet below the crown. Siphon primer on waterward shoulder. 36-inch steel (not concrete as original description noted) pipe with shut-off valve inside at landward toe ditch. (ABO No. 11227-1975) FS Date: 5/14/2013

View of waterward side. 12-inch pipe to the right and 14-inch pipe to the left.

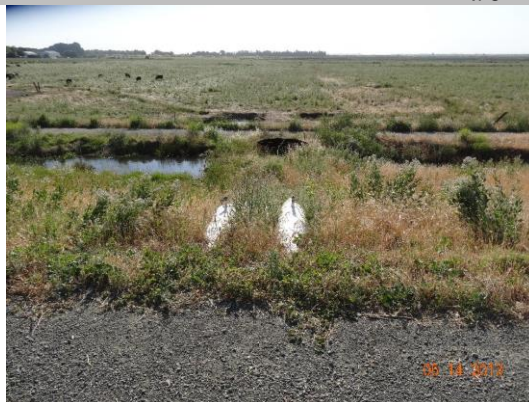
Photo 2 of 2 : UCIP_SP_2016_22043_37622.jpg

View of landward side with canal located at toe.

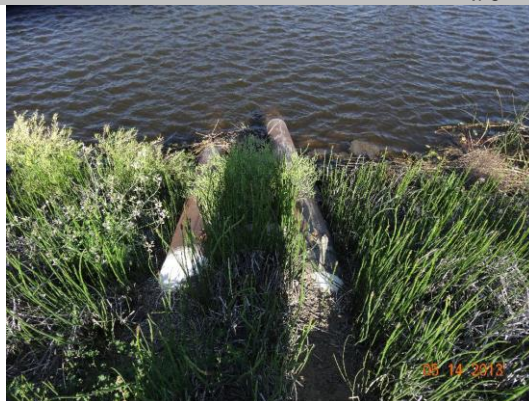
Photo 1 of 2 : UCIP_SP_2016_42024_60809.jpg

Comment Code					
Inspector Comment					
FS_ID:42024 DS_ID:20953 EP_NO: N/A Repair Type: Non-Urgent Crossing Status: Found UCIP Comments: Appears this crossing might have been recently modified--O&M manual calls for 8 inch pipe not 12 inch pipe, need additional information--exposed section of pipe is protected with white paint. Need to contact owner to obtain records. Recommend clearing vegetation along the pipe alignment. FIELD_STRUCT_DESC: 12-inch (not 8 inch listed in USACE) siphon through the levee approximately 3.2 feet below the crown. The existing 8-inch pipe listed in the O&M manual is no longer present at LM 0.1 (USACE-1959), no permit was found authorizing crossing modifications. FS Date: 5/14/2013

View of waterward side. 12-inch pipe on the right (u/s) and 14-inch pipe on the left (d/s).

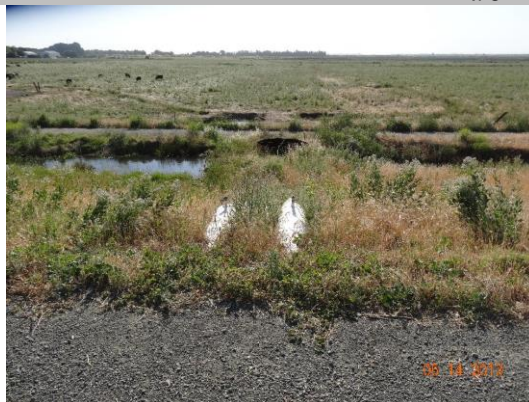
Photo 2 of 2 : UCIP_SP_2016_42024_60810.jpg

View of pipes from landward shoulder. Levee is a gravel road.

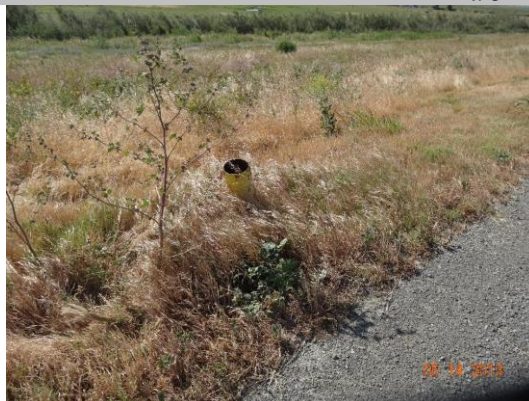
Photo 1 of 2 : UCIP_SP_2016_39946_71862.jpg

LM Start	0.79	Rating **	M	Issue No.	20
LM End	0.79	Issue Type +	En	Location *	CR
Category	Supplemental			GPS Latitude/Longitude	
				Start	End
Item	DWR UCIP Field Study			38.111078 °	38.111078 °
				-121.682011 °	-121.682011 °
DWR ID					
Comment Code					
Inspector Comment					
FS_ID:39946 DS_ID:24069 EP_NO: N/A Repair Type: Non-Urgent Crossing Status: Indicator Found UCIP Comments: Unable to determine if line crosses levee. Need to contact owner to determine if crossing goes through levee. Also need to determine permit authorizing work on landward side. FIELD_STRUCT_DESC: Steel stand pipe with PVC pipe inside located on landward shoulder. Rip rap located on waterward slope. Unable to determine if crossing goes through levee. Appears to be monitoring gas well. FS Date: 3/19/2009

View of landward side--standpipe located on slope.

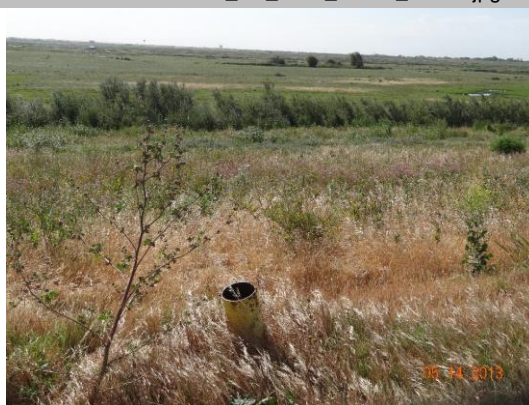
Photo 2 of 2 : UCIP_SP_2016_39946_71860.jpg

View of landward side--dense vegetation along slope.

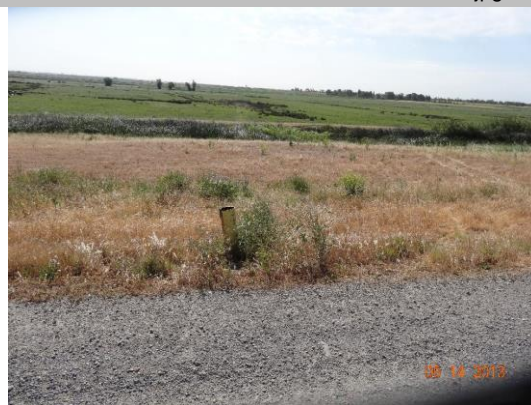
Photo 1 of 2 : UCIP_SP_2016_39947_71865.jpg

LM Start	1.40	Rating **	M	Issue No.	21
LM End	1.40	Issue Type +	En	Location *	CR
Category	Supplemental			GPS Latitude/Longitude	
				Start	End
Item	DWR UCIP Field Study			38.102422 °	38.102422 °
				-121.684289 °	-121.684289 °
DWR ID					
Comment Code					
Inspector Comment					
FS_ID:39947 DS_ID:24068 EP_NO: N/A Repair Type: Non-Urgent Crossing Status: Indicator Found UCIP Comments: Unable to determine if line crosses levee. Need to contact owner to determine if crossing goes through levee. Also need to determine permit authorizing work on landward side. FIELD_STRUCT_DESC: Steel stand pipe with PVC pipe inside located on landward shoulder. Rip rap located on waterward slope. Unable to determine if crossing goes through levee. Appears to be monitoring gas well. FS Date: 3/19/2009

View of landward side.

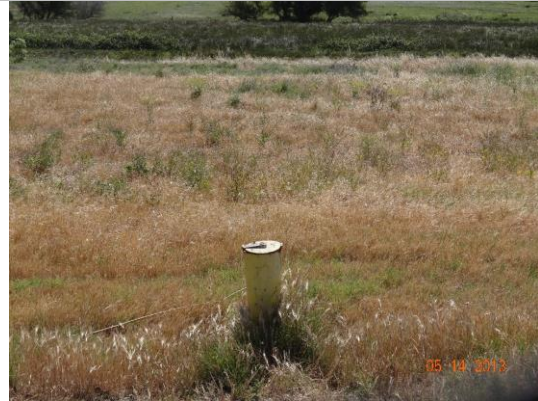
Photo 2 of 2 : UCIP_SP_2016_39948_71868.jpg

LM Start	1.77	Rating **	M	Issue No.	22 (cont)	
LM End	1.77	Issue Type +	En	Location *	CR	
Category	Supplemental			GPS Latitude/Longitude		
				Start	End	
Item	DWR UCIP Field Study			38.097105 °	38.097105 °	
				-121.684815 °	-121.684815 °	
DWR ID						
Comment Code						
Inspector Comment						
FS_ID:39948 DS_ID:24071 EP_NO: N/A Repair Type: Non-Urgent Crossing Status: Indicator Found UCIP Comments: Unable to determine if line crosses levee. Need to contact owner to determine if crossing goes through levee. Also need to determine permit authorizing work on landward side. FIELD_STRUCT_DESC: Steel stand pipe with PVC pipe inside located on landward shoulder. Rip rap located on waterward slope. Unable to determine if crossing goes through levee. Appears to be monitoring gas well. FS Date: 3/19/2009

View of landward side.

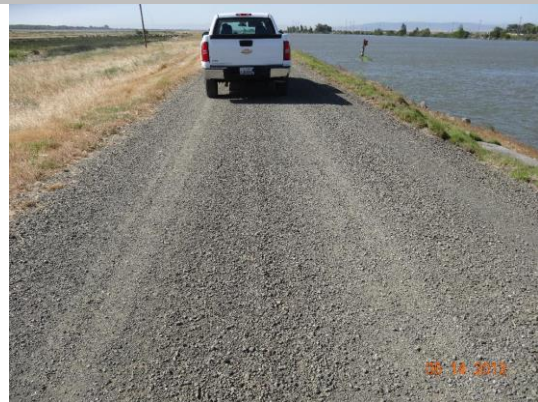
Photo 1 of 2 : UCIP_SP_2016_19545_33173.jpg

Comment Code					
Inspector Comment					
FS_ID:19545 DS_ID:20951 EP_NO: 2909A Repair Type: Non-Urgent Crossing Status: Found UCIP Comments: Appears this crossing might be been recently modified--exposed section of pipe is protected with white paint. Need to contact owner to obtain records. Recommend clearing vegetation along the pipe alignment. Dense vegetation on landward slope limits the inspector's visibility to identify signs of leaks along levee slope. FIELD_STRUCT_DESC: 8-inch siphon pipe through levee, 2.4 feet below crown. Cutoff wall around pipe at center of levee. Siphon breaker on apex of pipe on landward shoulder. Hand primer pump on landward slope. (Permit No. 2909A-1960) FS Date: 5/14/2013

View of levee crown looking downstream at crossing.

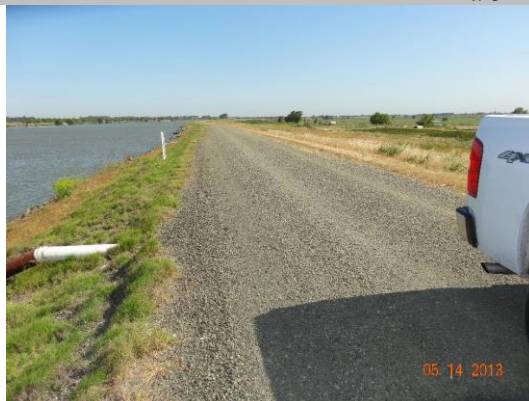
Photo 2 of 2 : UCIP_SP_2016_19545_33174.jpg

Comment Code						
Inspector Comment						
FS_ID:19545 DS_ID:20951 EP_NO: 2909A Repair Type: Non-Urgent Crossing Status: Found UCIP Comments: Appears this crossing might be been recently modified--exposed section of pipe is protected with white paint. Need to contact owner to obtain records. Recommend clearing vegetation along the pipe alignment. Dense vegetation on landward slope limits the inspector's visibility to identify signs of leaks along levee slope. FIELD_STRUCT_DESC: 8-inch siphon pipe through levee, 2.4 feet below crown. Cutoff wall around pipe at center of levee. Siphon breaker on apex of pipe on landward shoulder. Hand primer pump on landward slope. (Permit No. 2909A-1960) FS Date: 5/14/2013

View of levee crown looking upstream at crossing.
